# **PAINTED ALUMINUM HOOD AND ASSOCIATED CORROSION AT HEM**

October 2017

## Analysis of Painted Aluminum Hood and Associated Corrosion at Hem

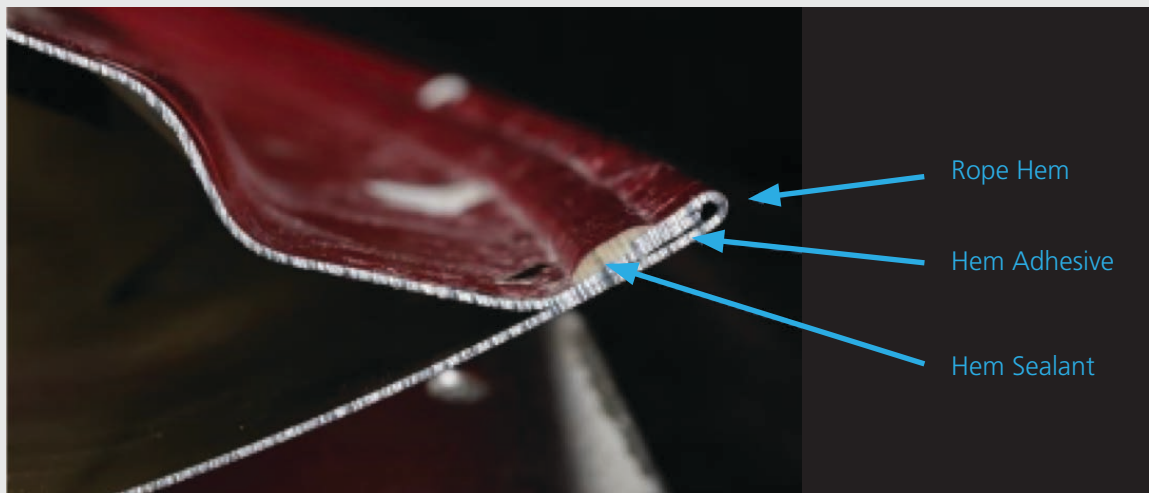
**FIG. 1: CROSS SECTION THROUGH HEM**

Cross section depicting the hem sealant, hem adhesive and rope hem.

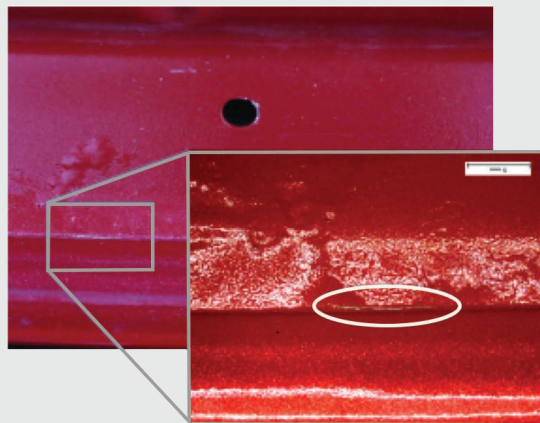
**FIG. 2: PAINT BLISTER**

General observations of “paint blister” at front edge of hem, hood underside.

- Evidence of cracks in paint/sealant are observed in regions where corrosion is apparent under paint
- Cracks seem to appear along edge of sealant bead

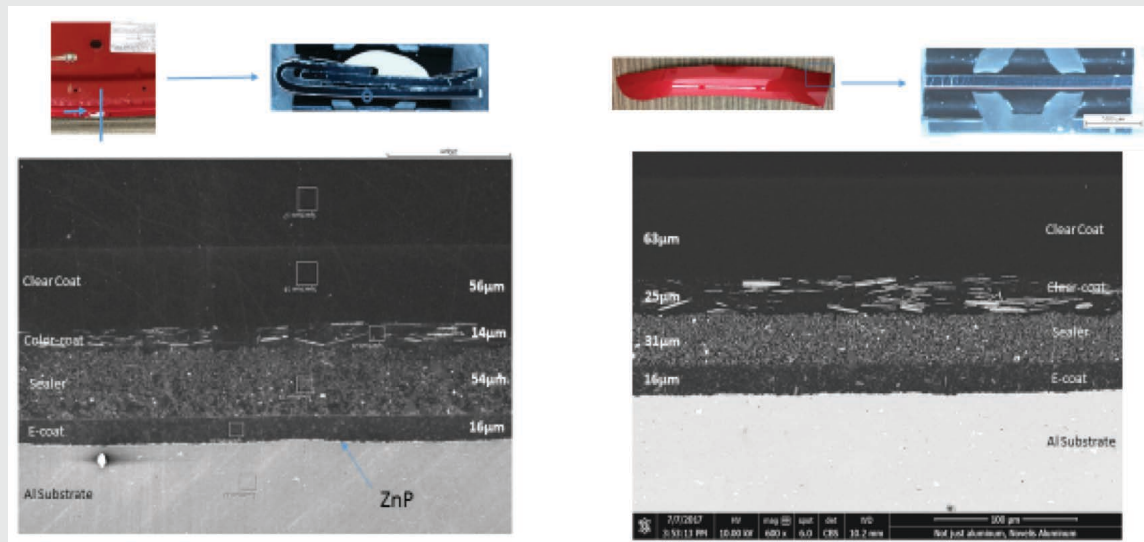
### FIG. 3: PAINT STACK COMPARISON

an e-coat layer, a primer coat, a color or base coat including some metal flake, and the clear top coat. The clear coat appears to have been sprayed with 2 applications in some regions (See Figure 3). All paint layer thicknesses appear to

Paint system layers away from hem surface.

Paint stack in affected region.

Paint stack in region away from affected region shows a slightly thinner sealer and a thicker top coat.

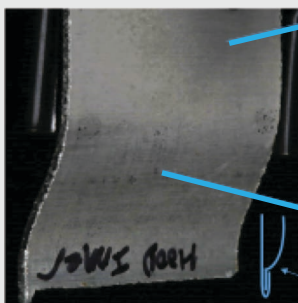
### FIG. 4: ZnP UNIFORMITY

be typical, and some non-uniformity in paint thicknesses is to be expected. However, as depicted in Figure 4, the Zn-Phosphate coverage close to the hem edge is less complete with gaps in the surface coverage.

As shown in Figure 4, the general coverage of the ZnP applied coating is uniform and quite compact in areas away from the local hem geometry. This layer of coverage should provide

excellent corrosion protection. Closer to hem detail itself, the ZnP coating becomes less uniform with gaps in the coverage. This has been previously observed on other hood samples, but the exact reason for this lack of coverage is not known. It might be difficult to get the ZnP to adequately etch and to nucleate in these regions, or the local metal working operations, leave a region with a “smeared” oxide that requires an additional degree of metal cleaning.

Regions of complete vs. incomplete phosphate coverage.

Further away from hem ZnP response is acceptable.

Discontinuities in the ZnP layer are found closer to the hem.

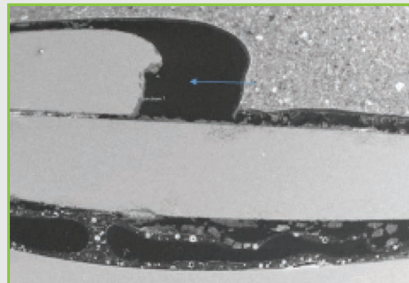
**FIG. 5: CROSS SECTIONS THROUGH HEM**

Significant IGC observed in region where paint has been removed due to corrosion.

- Hem sealant bead is observed to have pulled away from the Hem
- Voids in hem adhesive are indicative of excessive moisture in the adhesion
- Delamination of hem sealant bead as well as adhesive within the hem is observed.

Poor adhesion of Adhesive to Hem outer is observed.

Figure 5 depicts several features that are likely to contribute to the formation of the paint blisters. In some regions the hem sealer appears to have pulled away from the edge of the outer material (center photo). Additionally, the hem adhesive appears to contain a high void content which moisture entered the adhesive prior to the cure. There are regions where the adhesive bonding did not adhere well to the aluminum surface. The LH photo depicts a region of intergranular corrosion which is a secondary corrosion product after the filiform corrosion front had passed "over" this region.

The hem adhesive appears to be more porous, containing more voids than typically observed. This could be a result of the adhesive absorbing moisture prior to the application, or a sign that the level of residual oil on the formed part exceeded the adhesive's ability to absorb. All epoxy adhesives contain fillers and toughening particles, and to a certain degree voids, but a large number of voids accelerates the rate of in-service moisture uptake. Eventually, this moisture migrates to the metal adhesive interface, which

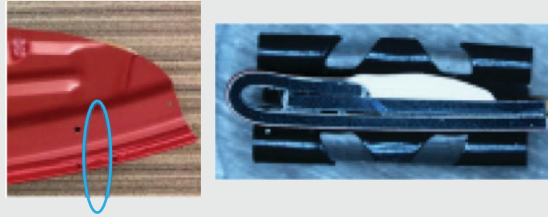
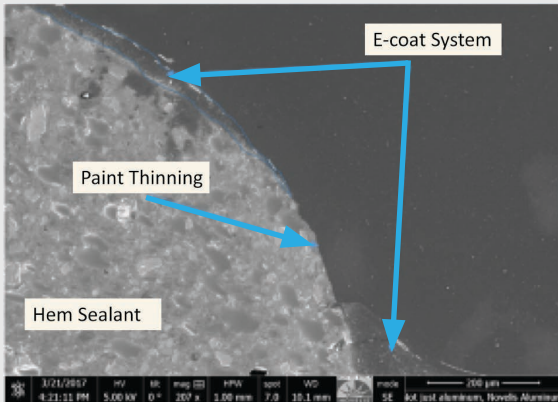
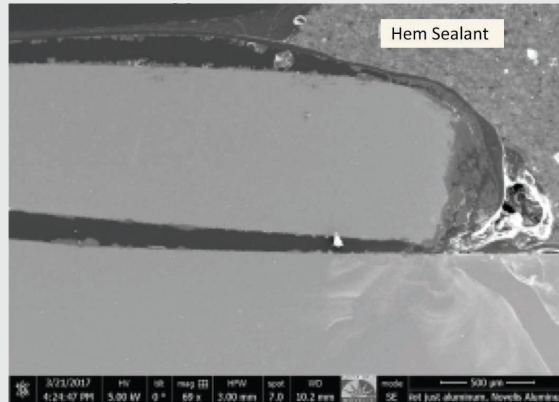
### FIG. 6: CORROSION ONSET

Section through the hem sealant indicating presence of e-coat and delamination and onset of corrosion.

Edge of hem bead reveals thinning of paint system which may compromise the paint system integrity leading to breaches and environment ingress.

Under-film corrosion is observed undercutting the paint system and the Hem Bead is delaminated due to corrosion

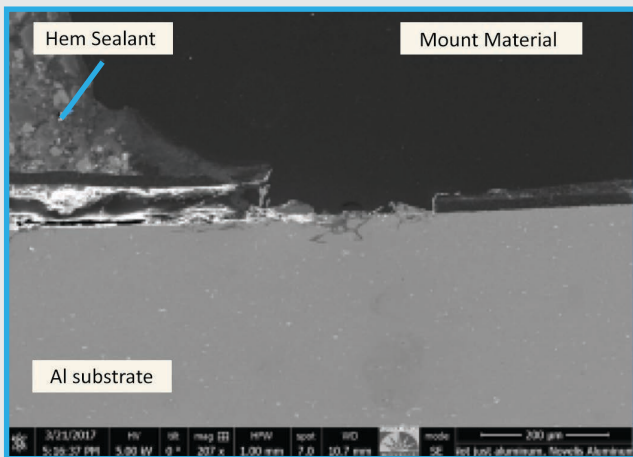
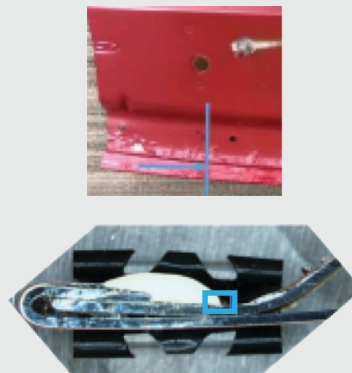
### FIG. 7: CORROSION PROPAGATION

Depicts corrosion propagating under the hem sealant, with associated secondary corrosion.

Breach in paint system and under hem sealant leads to undercutting, IGC, as well as delamination due to corrosion is seen.

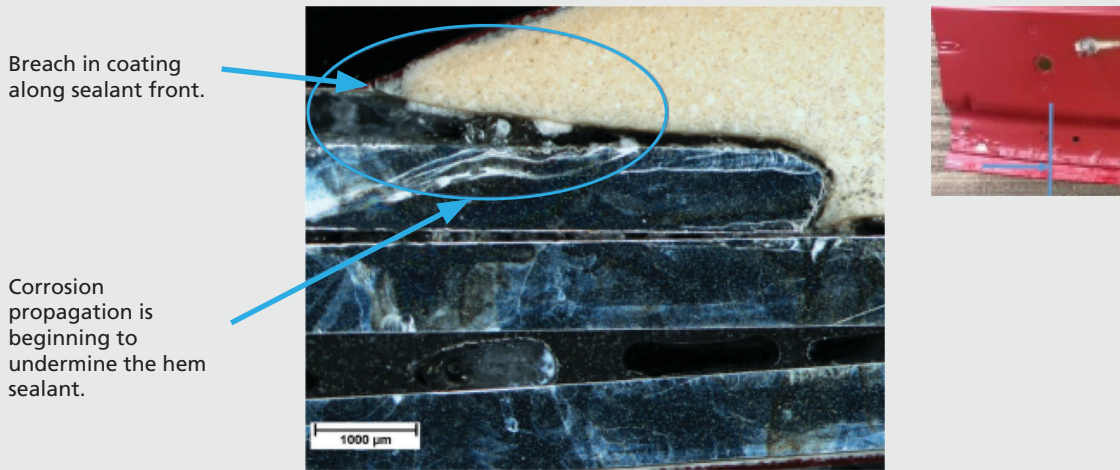
**FIG. 8: OPTICAL CROSS SECTION ANALYSIS**

Initiation of corrosion at hem sealant "front edge."

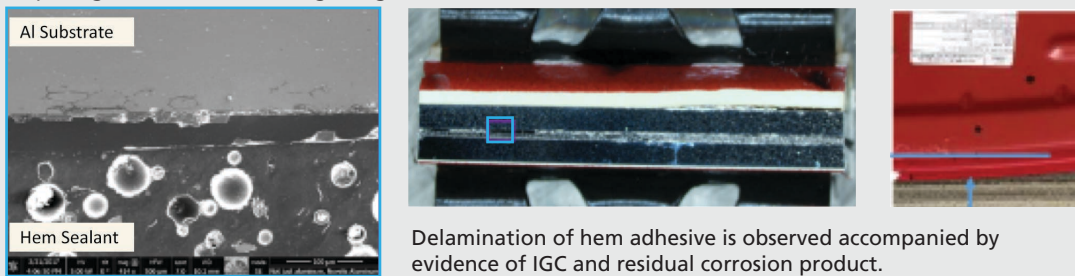
**FIG. 9: PARALLEL SECTION**

Depicting filiform corrosion migrating under the hem adhesive.

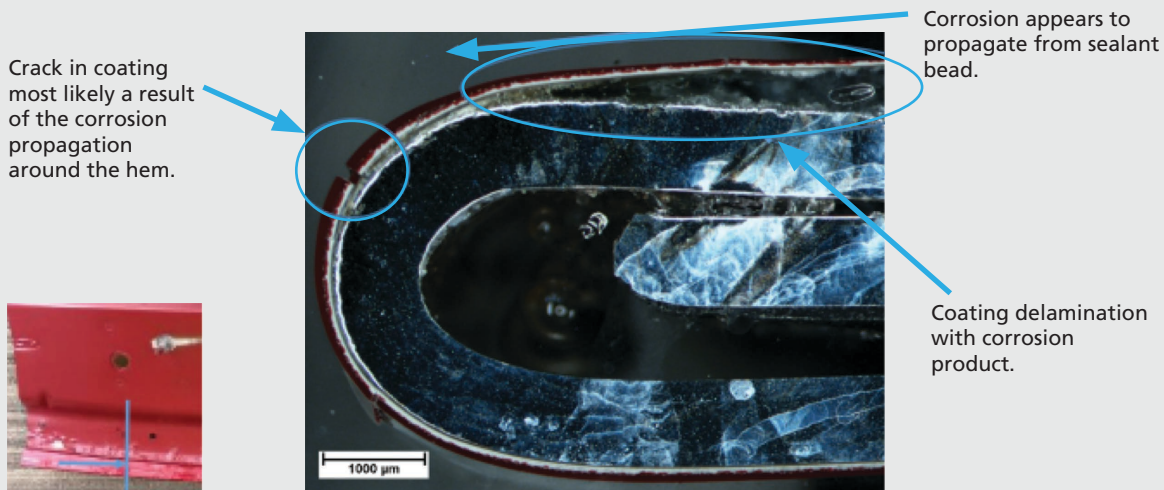
**FIG. 10: OPTICAL CROSS SECTION ANALYSIS**

Advanced stages of filiform corrosion migrating to hood outer surface.
