Analysis of

PAINTED ALUMINUM HOOD AND ASSOCIATED CORROSION AT HEM

October 2017 • Summary Version

Analysis of Painted Aluminum Hood and Associated Corrosion at Hem

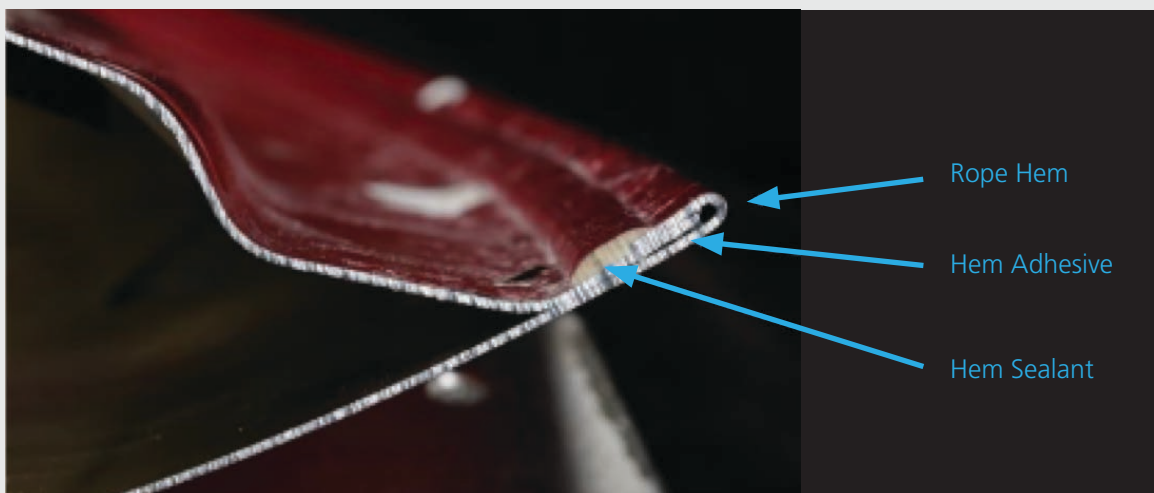
FIG. 1: CROSS SECTION THROUGH HEM

tional strength and good forming characteristics. Hence the hem is a rope hem and the outer panel does not completely flatten against the inner along the entire hem. (Section approximately 12-15mm in length perpendicular to hood outer edge.) This alloy is no longer used as a closure alloy, having been replaced by slightly less strong, much lower to Cu free alloys that are flat hemmable.

Cross section depicting the hem sealant, hem adhesive and rope hem.

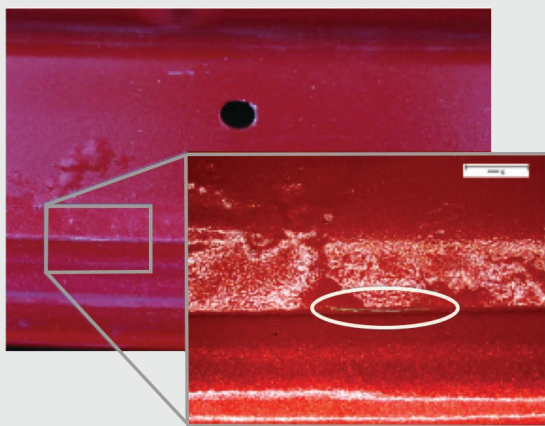
FIG. 2: PAINT BLISTER

General observations of "paint blister" at front edge of hem, hood underside.

Observation:

- Evidence of cracks in paint/sealant are observed in regions where corrosion is apparent under paint
- Cracks seem to appear along edge of sealant bead

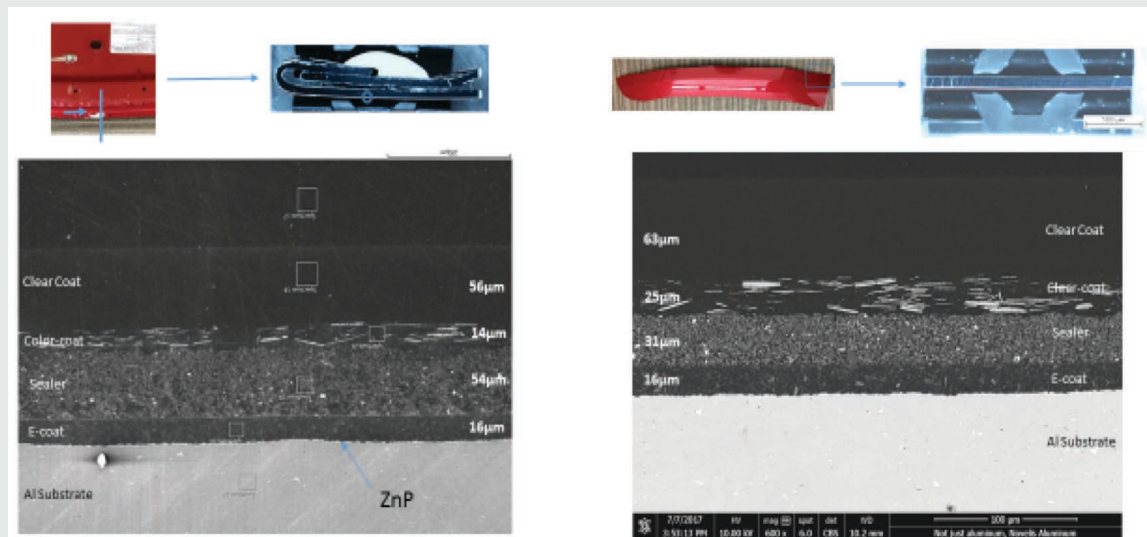
FIG. 3: PAINT STACK COMPARISON

The hood appears to have been “painted” in a traditional manner with a Zn-Phosphate layer, an e-coat layer, a primer coat, a color or base coat including some metal flake, and the clear top coat. The clear coat appears to have been sprayed with 2 applications in some regions (See Figure 3). All paint layer thicknesses appear to be

Paint system layers away from hem surface.

Paint Stack in affected region.

Paint Stack in region away from affected region shows a slightly thinner sealer and a thicker top coat.

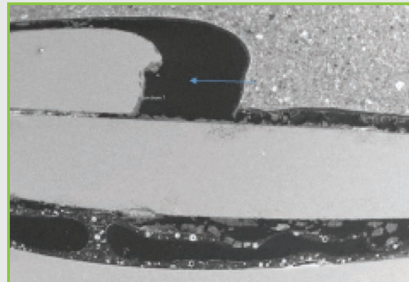
FIG. 5: CROSS SECTIONS THROUGH HEM

Cross section depicting the hem sealant, hem adhesive and rope hem.

Significant IGC observed in region where paint has been removed due to corrosion.

- Hem sealant bead is observed to have pulled away from the Hem
- Voids in hem adhesive are indicative of excessive moisture in the adhesion
- Delamination of hem sealant bead as well as adhesive within the hem is observed.

Poor adhesion of Adhesive to Hem outer is observed.

Figure 5 depicts several features that are likely to contribute to the formation of the paint blisters. In some regions the hem sealer appears to have pulled away from the edge of the outer material (center photo). Additionally, the hem adhesive appears to contain a high void content which moisture entered the adhesive prior to the cure.

There are regions where the adhesive bonding did not adhere well to the aluminum surface. The LH photo depicts a region of intergranular corrosion which is a secondary corrosion product after the filiform corrosion front had passed "over" this region.

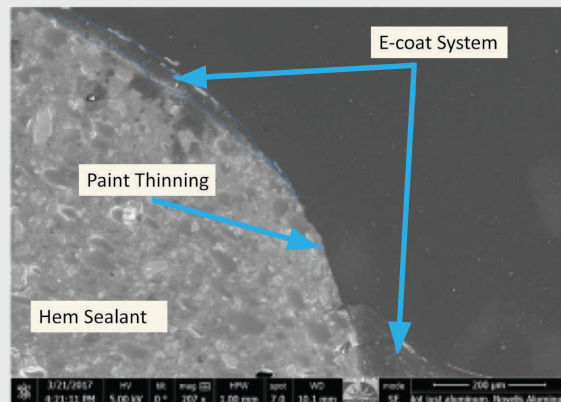
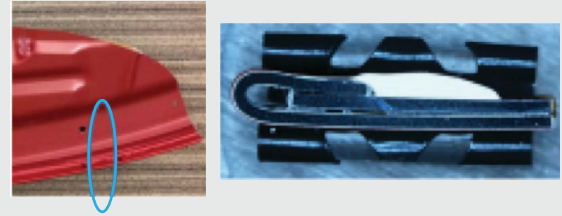
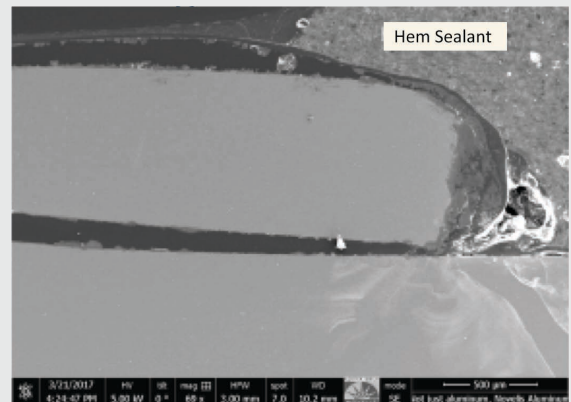
FIG. 6: CORROSION ONSET

Section through the hem sealant indicating presence of e-coat and delamination and onset of corrosion.

Edge of hem bead reveals thinning of paint system which may compromise the paint system integrity leading to breaches and environment ingress.

Under-film corrosion is observed undercutting the paint system and the Hem Bead is delaminated due to corrosion

The hem adhesive appears to be more porous, containing more voids than typically observed. This could be a result of the adhesive absorbing moisture prior to the application, or a sign that the level of residual oil on the formed part exceeded the adhesive's ability to absorb. All epoxy adhesives contain fillers and toughening particles, and to a certain degree voids, but a large number of voids accelerates the rate of in-service moisture uptake. Eventually, this moisture migrates to the metal adhesive interface, which may initiate filiform corrosion. If the metal surface is well pretreated, filiform corrosion is mitigated.

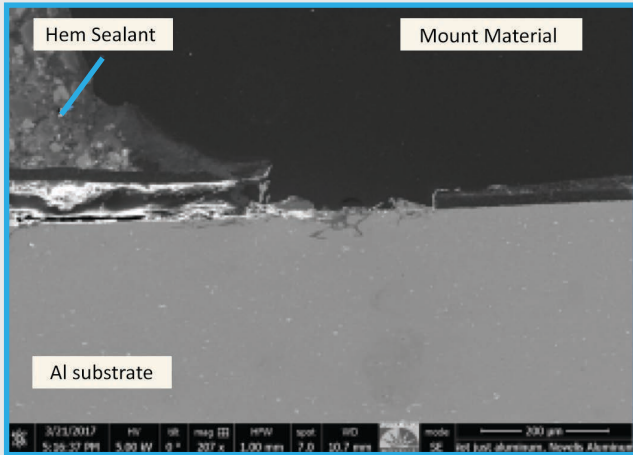
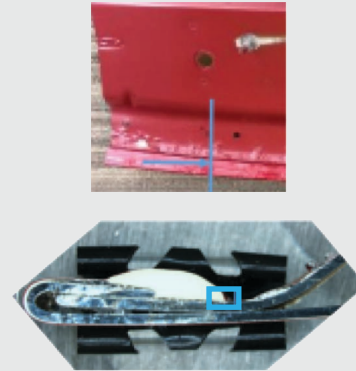
FIG. 7: CORROSION PROPAGATION

A bead of hem sealer was applied. This sealer appears to have been applied during the hood assembly. Extensive corrosion has been observed under the sealer and as a result, some of the un-

derlying layers are difficult to observe. The layers on top of the sealer suggest it was applied at the assembly stage. As previously shown, there are regions where the sealer pulled away from the metal surface, and filiform corrosion is observed at the edges of the sealer. It should be noted that once filiform corrosion has been initiated at the various defects, such as under the hem sealer, it may grow away from this initiation site and under the paint layers. The lack of ZnP or e-coat under the hem sealer, places all corrosion preventative measures to be provided by: the quality of the hem sealer, the cleanliness of the underlying metal, and the uniformity and integrity of the sealer application. This particular example appears to suggest the sealer was unable to provide the necessary level of protection to the underlying metal.

Depicts corrosion propagating under the hem sealant, with associated secondary corrosion.

Breach in paint system and under hem sealant leads to undercutting, IGC, as well as delamination due to corrosion is seen.

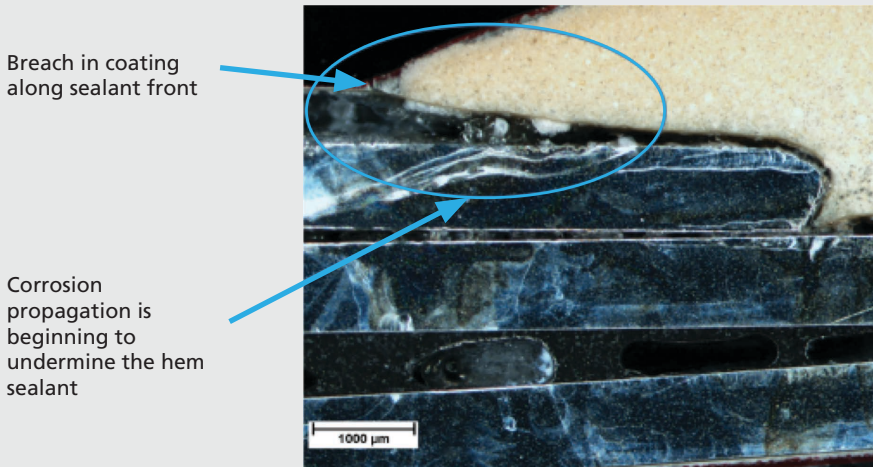
FIG. 8: OPTICAL CROSS SECTION ANALYSIS

Initiation of corrosion at hem sealant "front edge."

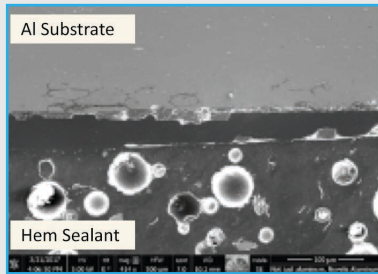
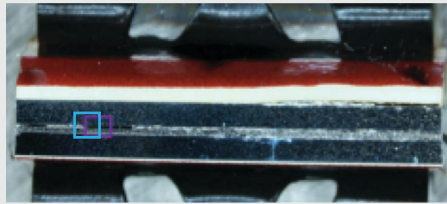
FIG. 9: PARALLEL SECTION

Depicting filiform corrosion migrating under the hem adhesive.

Delamination of hem adhesive is observed accompanied by evidence of IGC and residual corrosion product.

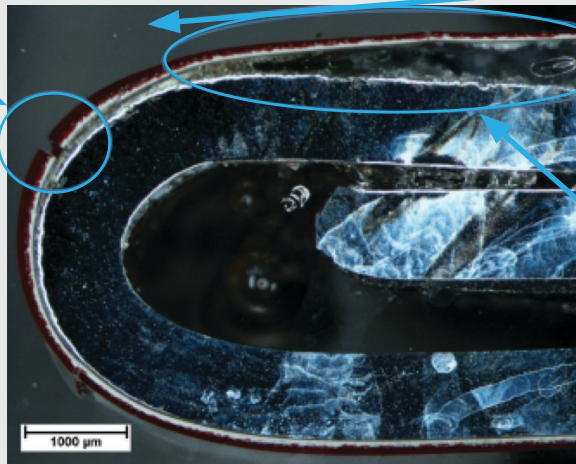
FIG. 10: OPTICAL CROSS SECTION ANALYSIS

Advanced stages of filiform corrosion migrating to hood outer surface.

Crack in coating most likely a result of the corrosion propagation around the hem.

Corrosion appears to propagate from sealant bead.

Coating delamination with corrosion product.
